**Former Weapons Storage Area  
Plattsburgh Air Force Base  
Plattsburgh, New York**

**FINAL  
NFRAP DECISION DOCUMENT  
(for Radiological Waste Investigation)**

**NFRAP DECISION DOCUMENT  
(For Radiological Waste Investigation)**

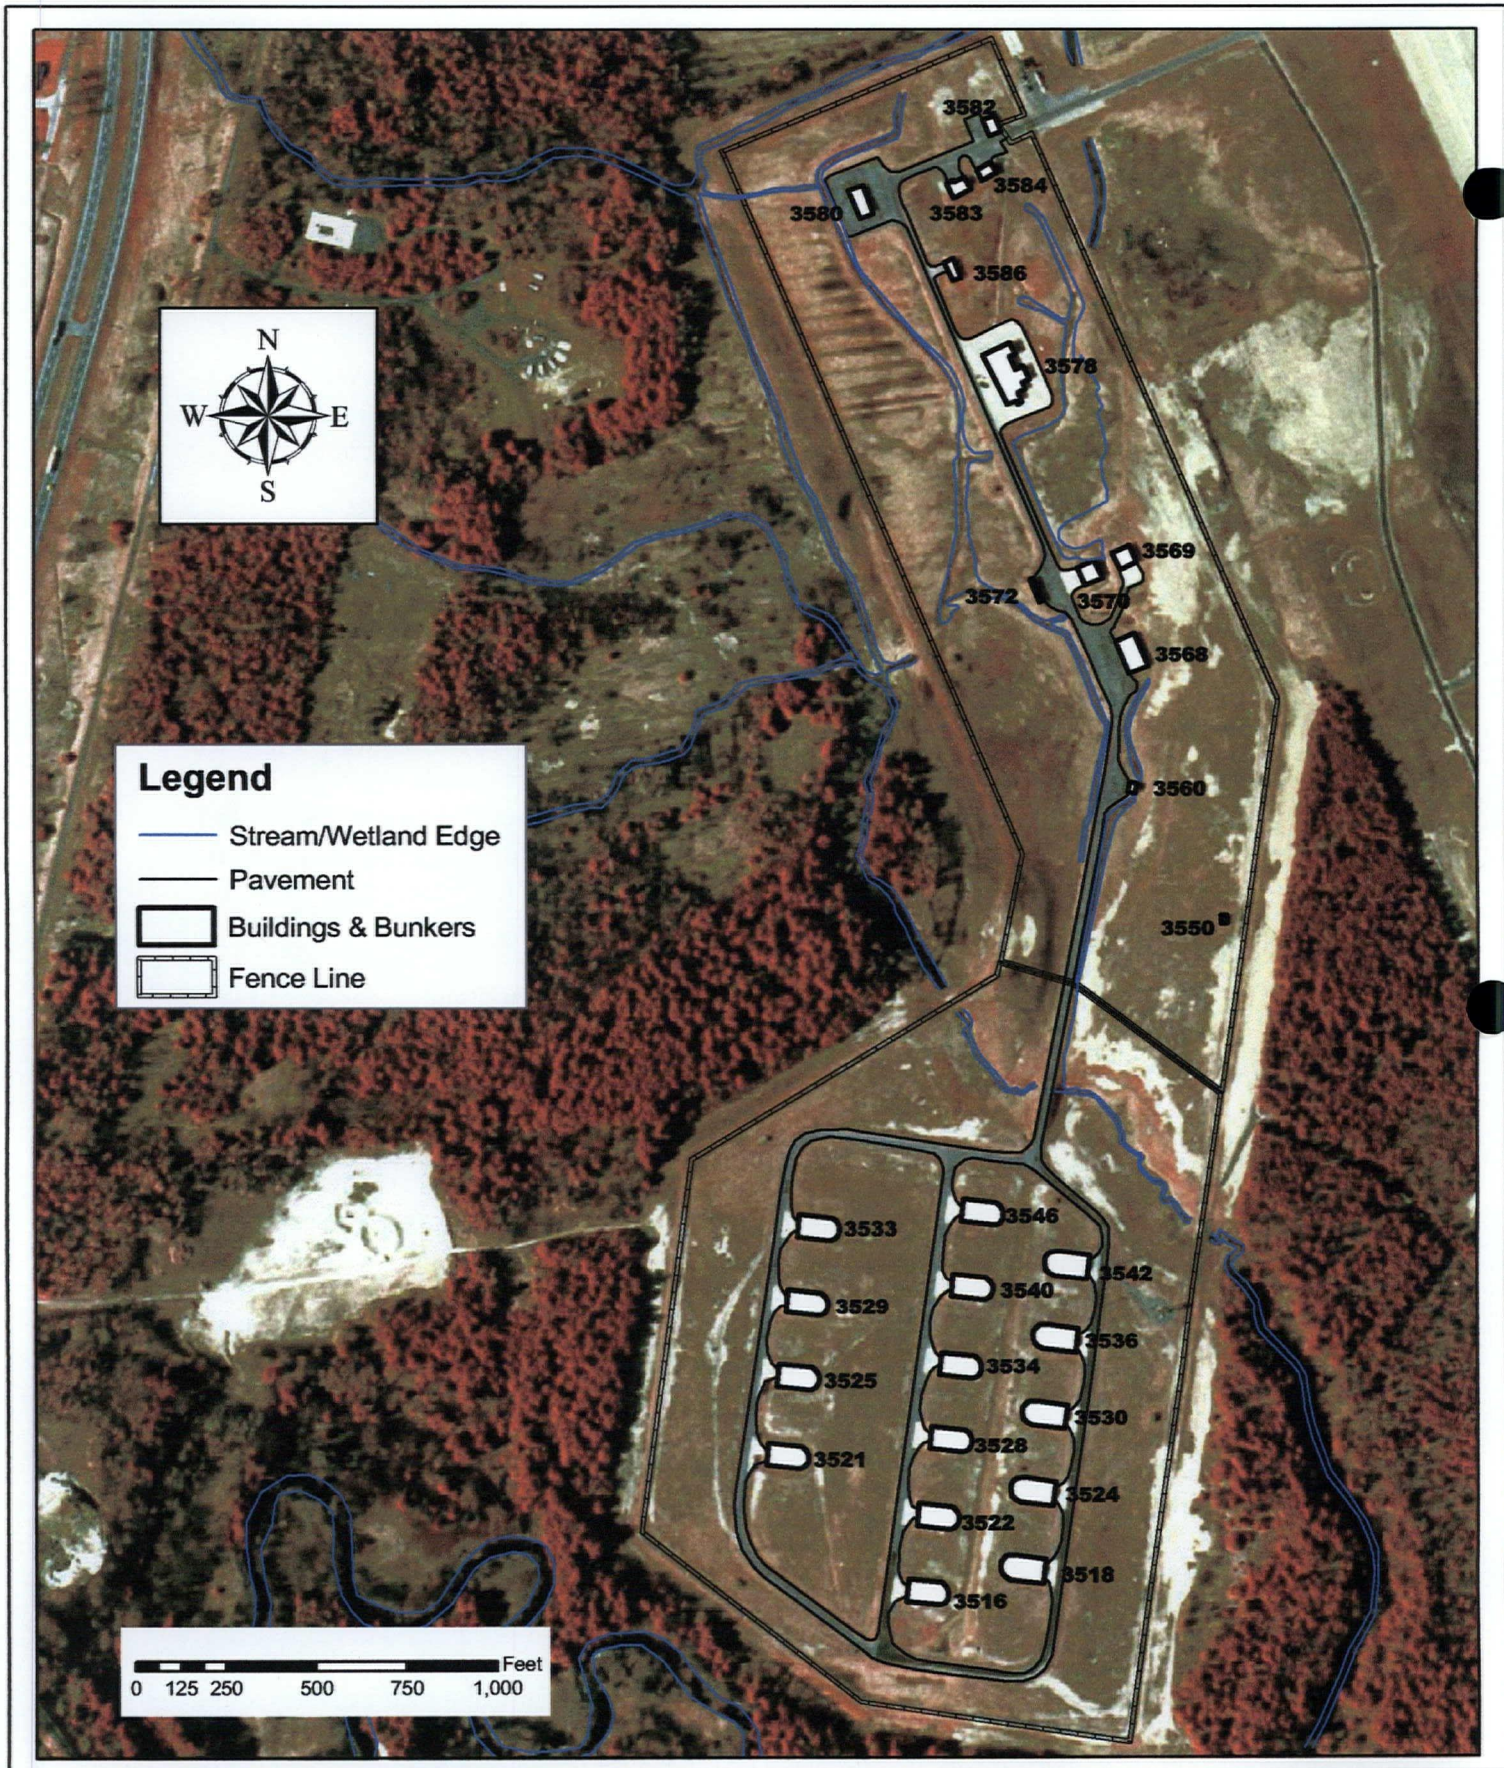
Plattsburgh AFB WSA	Date: 2-10-04 Project #: 03-6001.08	Figure 2-1
	Weapons Storage and Maintenance Building Area	File Name: WSA Prepared By: JTM

The Plattsburgh AFB former WSA covers approximately 100 acres west of the airfield. This was a secured area enclosed by an 8-foot-high chain-link fence topped with barbed wire which was used for storage and maintenance of various types of munitions and weapon component systems (e.g., conventional and nuclear missiles and bombs). The layout of the former WSA is shown in Figure 2-1 and is described in detail below. Facilities constructed with the WSA included earth-covered storage bunkers (or igloos), other munitions storage buildings, maintenance buildings, and administrative and security buildings. In the southern portion of the WSA, there are 15 earth-covered bunkers (Figure 2-1) 13 of which are identical made from reinforced concrete and covered with soil (Buildings 3518, 3521, 3522, 3524, 3525, 3528, 3529, 3530, 3533, 3534, 3536, 3540 and 3546). The bunkers have an open floor and curved walls that form an arch cover (2,404 sq ft). The concrete roof is covered with approximately two feet of soil. Entrance to the bunkers is provided via two large steel doors attached in front of a concrete apron that connects to an access road. The other two bunkers, Buildings 3516 (1,611 sq ft) and 3542 (1,302 sq ft) are similar in design, but have different interiors. These bunkers were designed to house the components of early nuclear weapons. Within these buildings vaults were constructed to house the nuclear components.

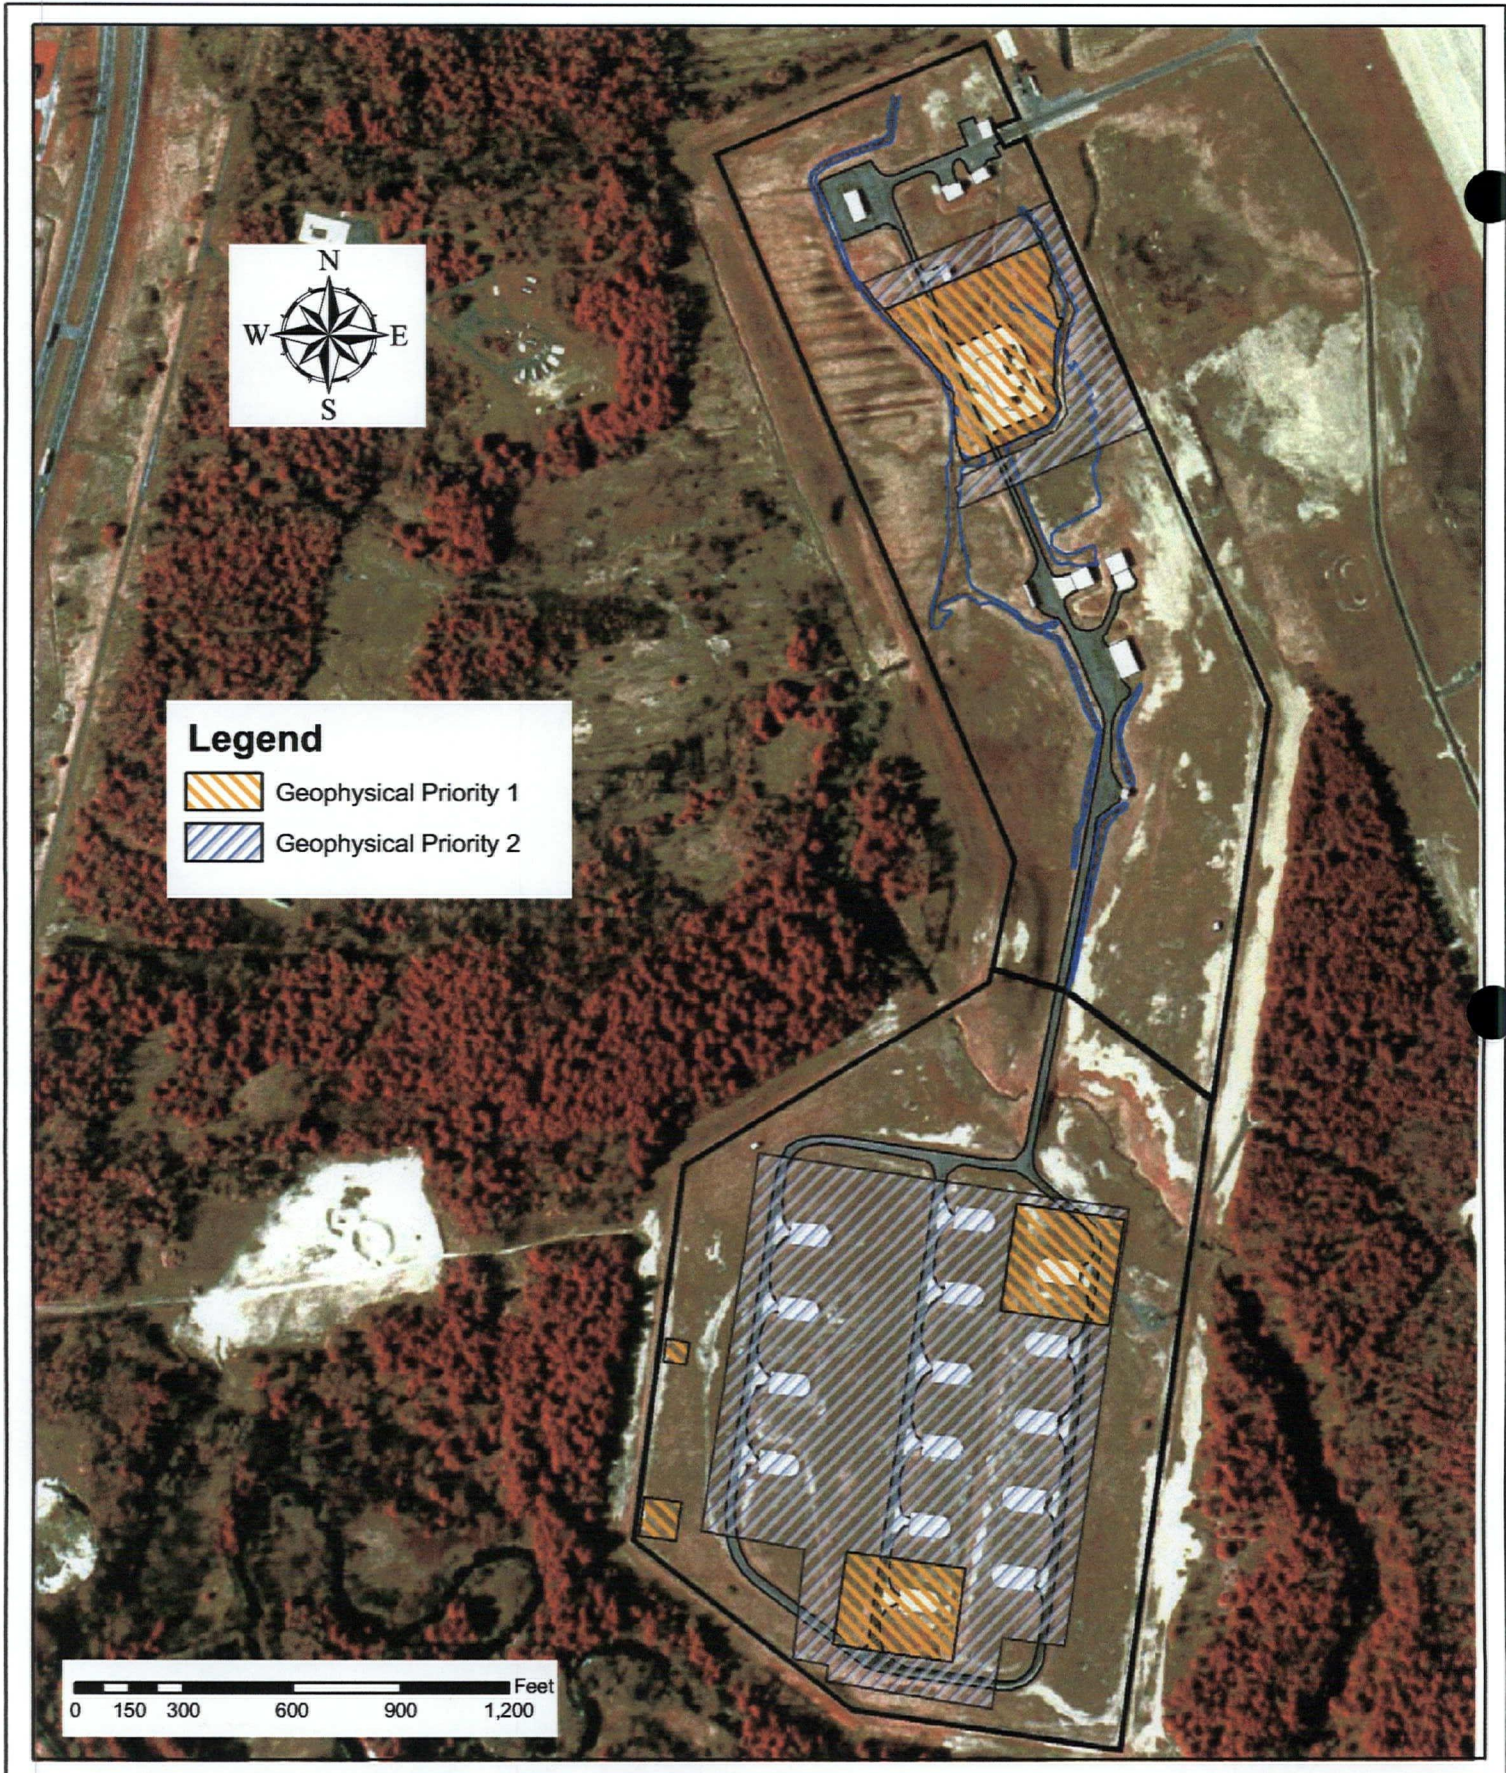
Plattsburgh AFB WSA	Date: 1-9-04 Project #: 03-5001.06	Figure 5-1
	Building 3578 & Weapons Storage Area	File Name: Geophysical Priority Areas Prepared By: JTM

An EM profiling survey was conducted between October 3 and October 16, 2003 covering more than 37 acres (7.8 in the area surrounding the Building 3578 and 29.6 in the WSA bunker area). Data was collected at more than 90,000 locations. Priority 1 areas were completed with a traverse separation of 5 feet, while priority 2 areas were surveyed with a traverse separation of 10 feet in accordance to the field sampling plan (FSP).

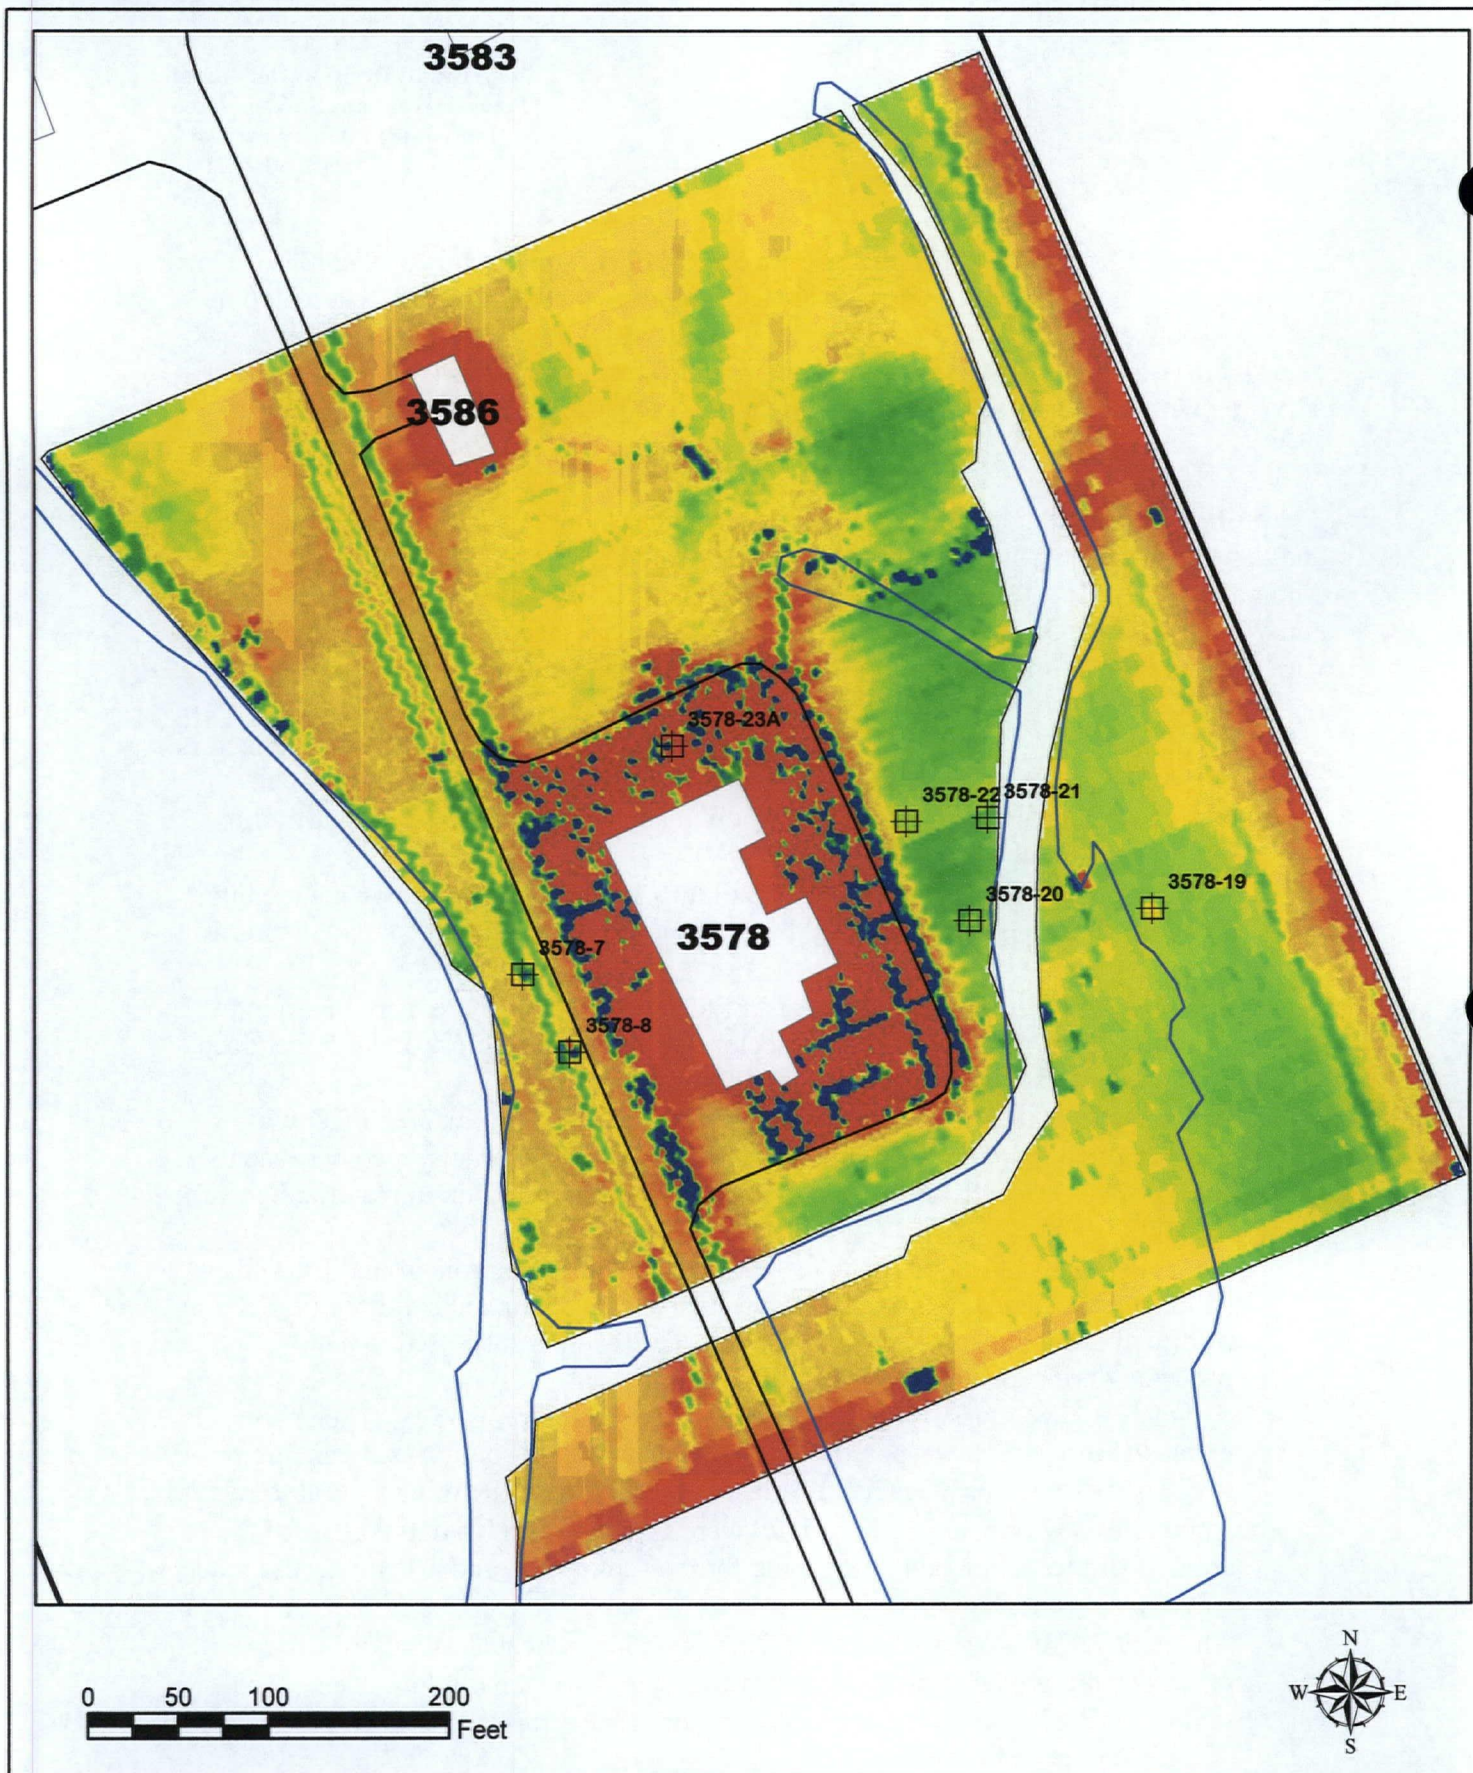
<p>Plattsburgh AFB WSA</p> <p>Geophysical Anomalies Building 3578</p>	<p>Date: 1-26-04 Project #: 03-5001.08 File Name: Geophysical Anomalies Prepared By: JTM</p>	<p><b>Figure 5-2</b></p>
--	---	--	------------------------------

EM profiling investigations identified eleven geophysical anomalies near Building 3578 and three anomalies in the WSA bunker area that could not be readily explained. Anomalies 3578-7, -8, -19, -20, -21, -22, -23A, -25, -27, -28, and -29 near Building 3578 and WSA-34, WSA-35, and WSA-37 (Figures 5-2 and 5-3) were further investigated with Ground Penetrating Radar (GPR). GPR data has indicated that:

- Anomalies 3578-7 and -8 located southwest of Building 3578 are strong reflectors one to three feet across and one to one and one-half feet deep. These may be buried structures associated with the buried adjacent utilities and do not fit the profile of a small disposal trench.

- Anomaly 3578-19 is located east of Building 3578. It has no known source but is less than three feet across, and is thus does not fit the profile of a small disposal trench.

- Anomaly 3578-20 is located just east of the edge of the concrete apron around Building 3578. This is a strong reflector one to two feet across and 2.5 feet deep and does not fit the profile of a small disposal trench.

- Anomaly 3578-21 is a concrete pad approximately 5 feet long and 3 feet wide and, although it did not exhibit a large EM anomaly, it was surveyed because its function was not understood. The results did not indicate buried material beneath the pad.

- Anomaly 3578-22 is located 15 feet east of the concrete apron around Building 3578 and is a somewhat irregular depression. The GPR results did not fit the profile of a small disposal trench, and the depression is suspected to have occurred during a soil removal action.

- Anomaly 3578-23A is located on the north side of Building 3578. The pad was expanded in 1960, it was possible that a disposal trench could have been dug prior to the pad extension. The GPR results did not fit the profile of a disposal trench.

- Anomalies 3578-25, -27, -28, and -29 were associated with a culvert east of the creek, a former septic tank, the piping for the septic tank, and a small access road culvert, respectively.

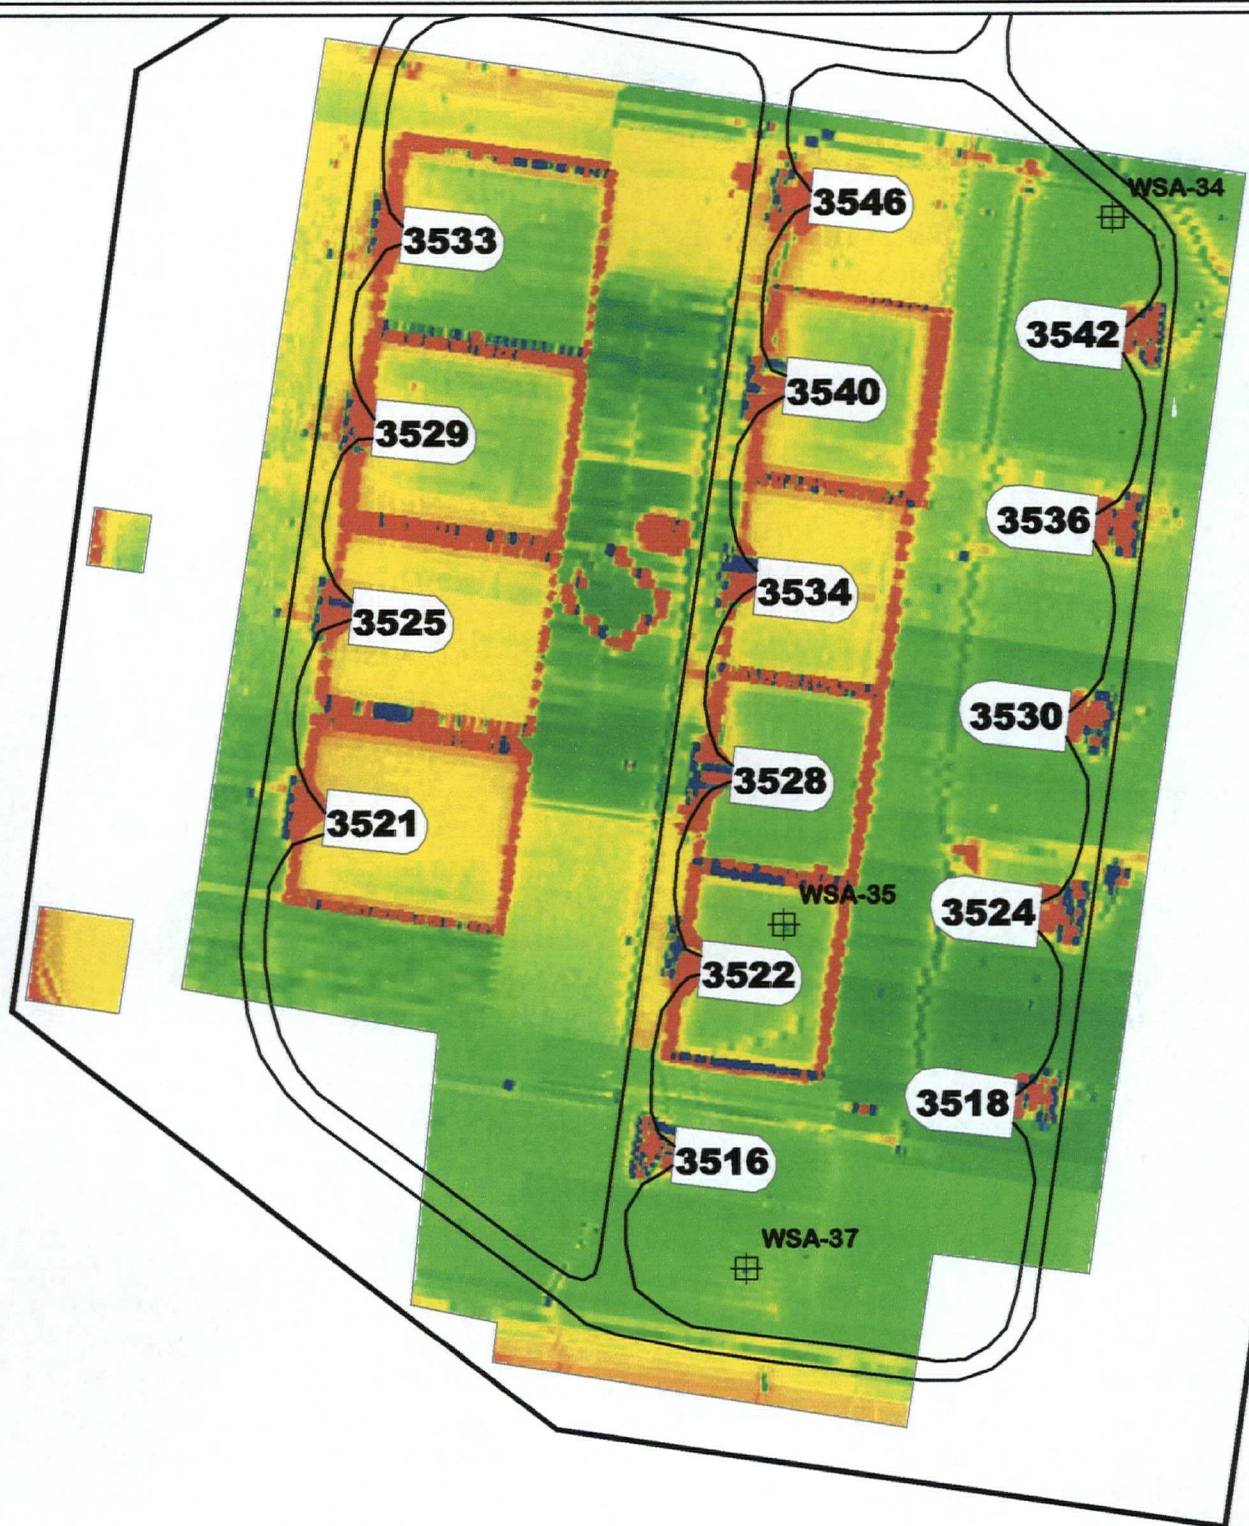
**Figure  
5-3**

- Anomaly WSA-34 located north of Building 3542 indicated a shallow strong reflector, interpreted to be from a metallic object less than 0.5 foot deep. A soil sample was collected at the anomaly location. The sample confirmed the absence of radionuclides of concern.

- Anomaly WSA-35 located north of Building 3522 also indicated a shallow strong reflector, interpreted to be from a metallic object less than 0.5 foot deep. A soil sample was collected, however this sample also failed to identify the presence of the radionuclides of concern.
- Anomaly WSA-37 located southeast of Building 3516 indicated a small object approximately one foot deep. As with the two other WSA anomalies a soil sample was collected which failed to identify the presence of the radionuclide of concern.

Based on these findings it has been concluded that it is unlikely that depleted uranium wastes from the maintenance of large open pit weapons systems are disposed of within the boundaries of the former WSA.
